Geomorphological method in the elaboration of hazard maps for flash-floods in the municipality of Jucuarán (El Salvador)

C. Fernández-Lavado, G. Furdada, M. A. Marqués

C. Fernández-Lavado, G. Furdada, M. A. Marqués. Geomorphological method in the elaboration of hazard maps for flash-floods in the municipality of Jucuarán (El Salvador). *Natural Hazards and Earth System Sciences*, 2007, 7 (4), pp.455-465. hal-00301688

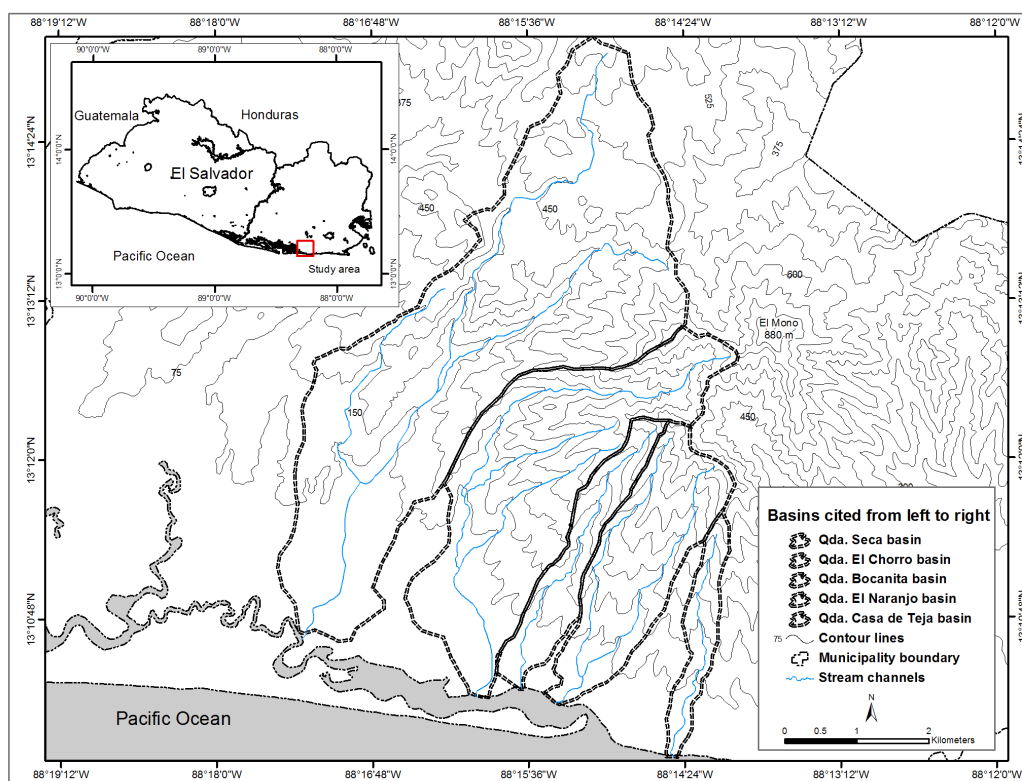
Fig. 1. Study Area. El Salvador is the smallest country in the Central American isthmus.

The study area (Fig. 1) is located in the municipality of Jucuarán (SE El Salvador). The municipality has an area of 32.7 km² and is characterized by stream channels running from the coastal range to the Pacific Ocean. In the study area there are effusive rocks forming part of the Bálsamo unit defined as a succession of basic and intermediate effusive volcanic rocks, pyroclastites and epiclastites (Baxter, 1984) which readily disintegrate.

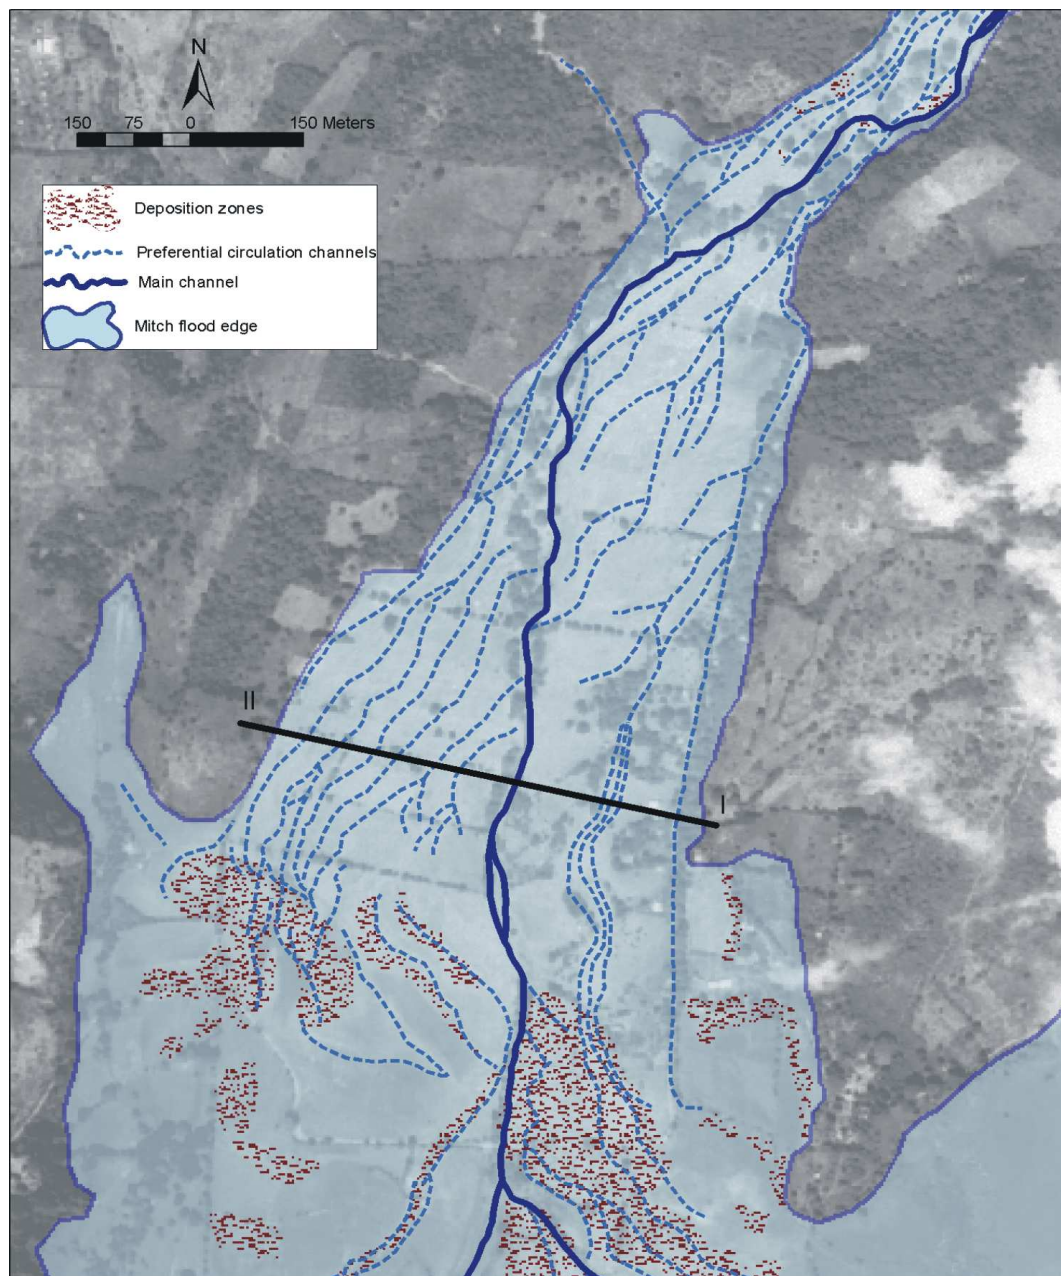
Fig. 2. Photointerpretation. Observations: main channel, preferential circulation channels and sedimentation zones. Location of the cross section used for the general geomorphological estimation of the flow is shown (see Sect. 2.2.3.).

The aerial photographs of December 1998 show a number of geomorphological effects caused by hurricane Mitch (Fig. 2a). These effects include reactivation of alluvial fans, preferential stream channels, stagnant water, overflow in meanders, erosion and deposition zones. In addition a number of anthropic constructions influencing the flood i.e. manmade terraces to cultivate cotton can also be identified.

The discharge in the middle part of alluvial fan was estimated (Fig. 2a). This estimate was used to obtain an approximate discharge value that represented only one order of magnitude of the flow. The cross section was obtained using GIS techniques. A rough DEM, useful for other purposes than obtaining cross sections, was constructed from the topographic map at a scale of 1:25 000 (see Sect. 1.3). The DEM allowed us to draw a rough, approximate cross section in the alluvial fan (Fig. 2). The limits of the flood and the height of the water level were well known: the flood occupied the whole width

In our work Manning and paleohydraulic methods were applied in one of the best possible cross sections (approx. 300 m North of the map in Figs. 2, 5 and 6), made at the apex of the alluvial fan and assuming that the flow that spread over the fan must have passed through this section.

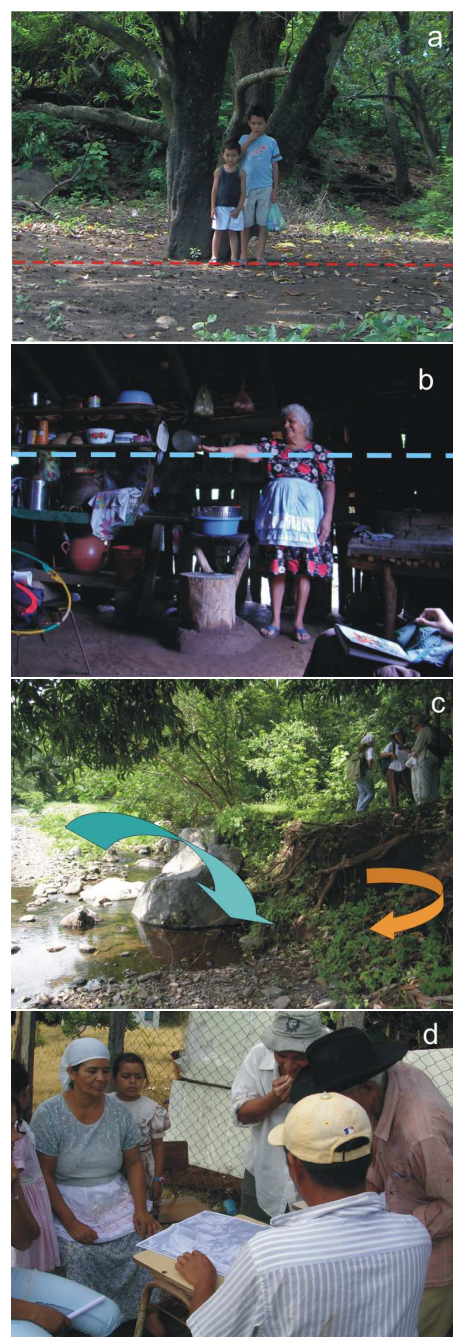
Fig. 3. Integrated geomorphological method. Techniques and indicators employed. (a) Tree roots covered by fine sediments, indicating low flood energy. The red line indicates the surface of the fine sediment deposited, covering the base of the trunk, at the level of the tree. (b) Woman indicating water level inside her house during flash-flood peak. (c) Displacement of large boulders. Undermining in a meander. Critical overflow points were, in some cases, water canalizes to preferential circulation channels. (d) Community Workshop. Persons working with enlarged aerial photographs.

Evidence from aerial photographs is corroborated during fieldwork and eyewitness reports are obtained from local people: (1) field evidence: critical points of overflow, big boulders displaced by flow energy, tree roots covered by fine sediments, vegetation influence and sediment retention, etc. and (2) eyewitness reports: high water levels during peak discharge, material transported by flood, damage caused by flow, etc. which give an idea of the energy of the flash flood (Figs. 3a–c).

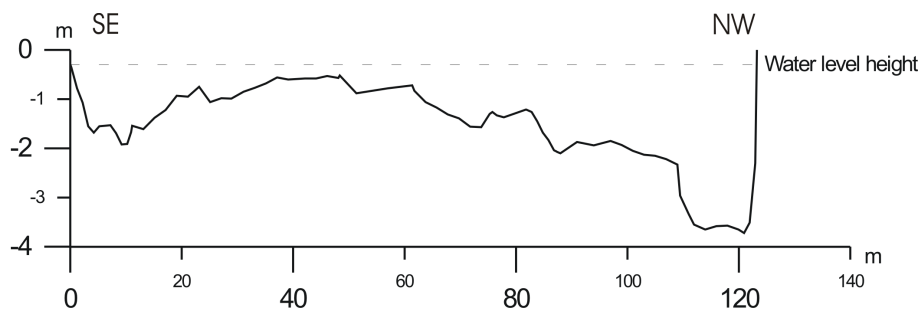
Fig. 4. Cross section made in Quebrada Seca at the apex of the alluvial fan. The Manning and the paleohydraulic methods were applied. The section was obtained in the field, using compass, clinometers and a meter tape measure.

To apply the Manning and the Paleohydraulic methods, one cross section was obtained. This section was measured in the field by using a compass, a clinometers and a meter tape measure, and with the aid of a native inhabitant who cleared off the vegetation grown since 1998. The slope of the channel was obtained also in the field, close to the cross section and along the lowest terrace. The location of the cross section was carefully chosen. As commented in section 1.3., topographic maps at 1:25 000 scale were useless to build cross sections at an appropriate scale and the difficulty of access (rainforest) made very difficult to obtain series of cross sections. It was assumed that all the water that spread over the

alluvial fan had passed through this section (Fig. 4), located near the apex of the alluvial fan.

In order to apply the Manning equation, the area corresponding to the cross section of the stream (Fig. 4) is needed to calculate peak discharge (Harrelson et al., 1994). Subsequently the Manning equation was used:

where v is the velocity, d is the mean value of five intermediate axes of the five largest boulders displaced by flood. Downwards the section (Fig. 4), a number of blocs that had been transported across it by the flow (eyewitness and Alcoverro et al., 1999) was measured and the five largest blocs were selected. The resulting d value was 1462 mm, which means a velocity of 6.21 m/s. Once the velocity and the area of the cross section are known (Fig. 4), the following equation can be applied:

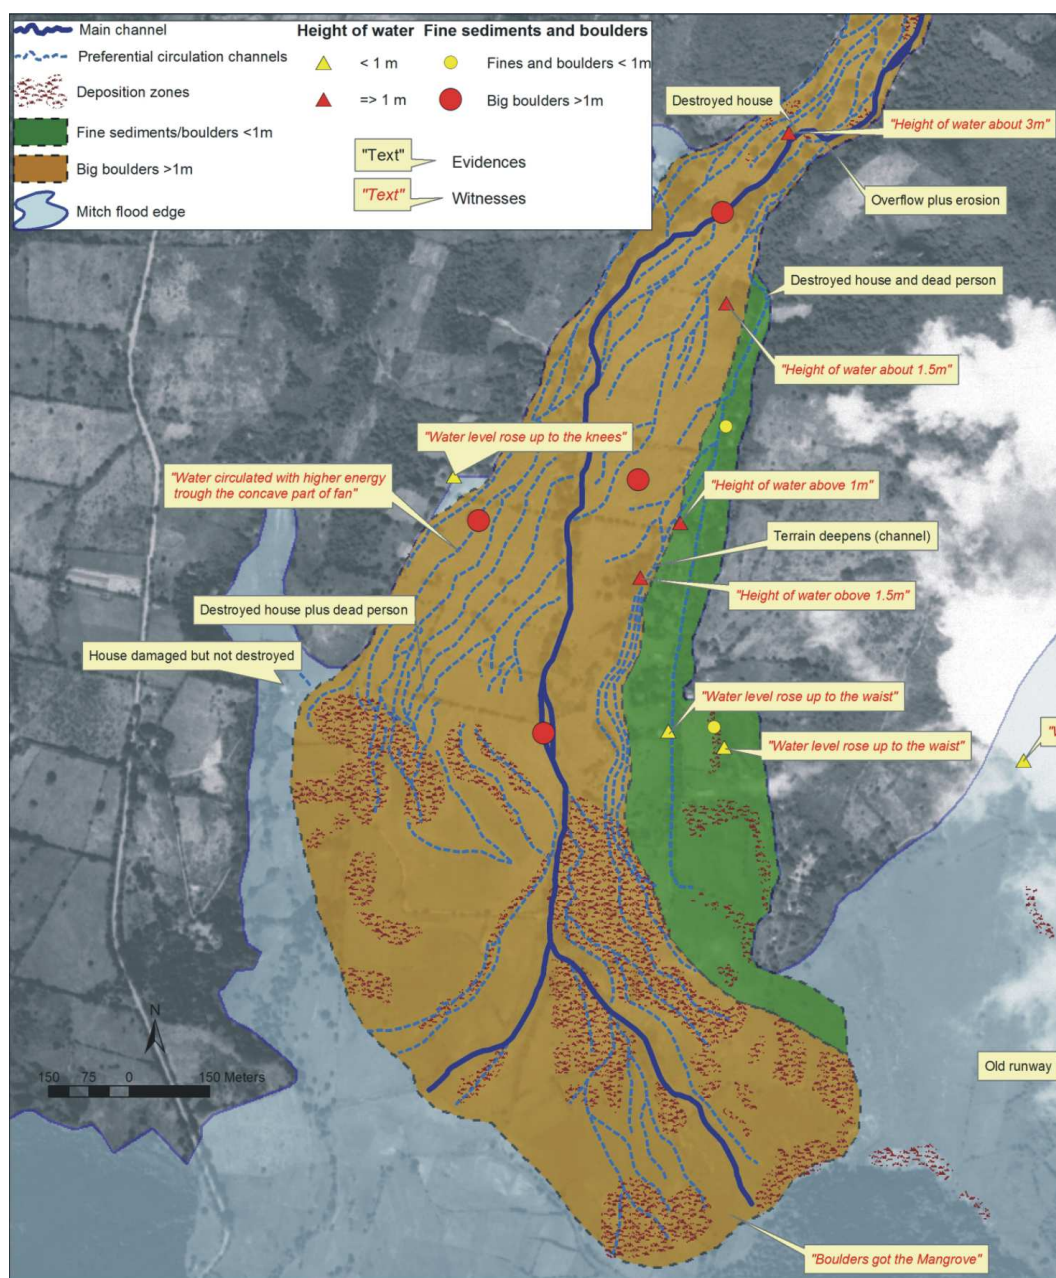
Fig. 5. Geomorphological indicators map at Quebrada Seca stream.

From the comprehensive/integrated geomorphological map (Fig. 5) we can construct a hazard map (Fig. 6).

no doubt, a very low frequency, extreme event. So we take this event as the reference one. We obtained sufficient information about water levels and flow energy from geomorphological analyses and eyewitness reports to construct a map. We can superimpose all these data (synthesized in Fig. 5) to elaborate a hazard classification (Table 2):

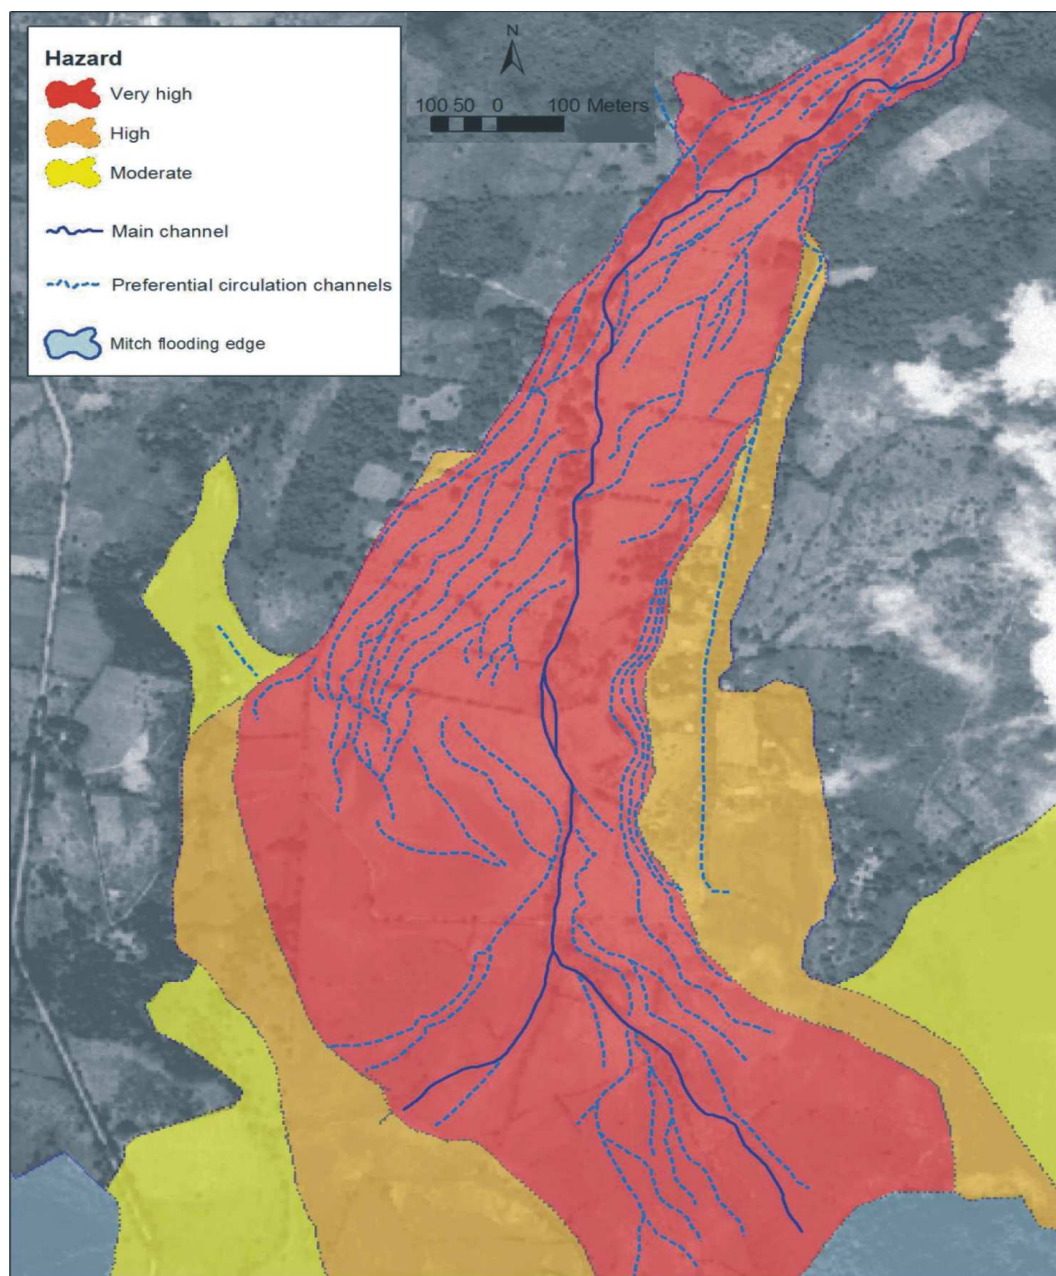
Fig. 6. Flood Hazard map at Quebrada Seca stream.

Very high hazard zone. Big boulders displaced by flow energy. Water levels above 1 m and/or the result of multiplying velocity (v) and height (h) exceeds $5 \text{ m}^2/\text{s}$ (where velocity is estimated by the paleohydraulic method).

High hazard zone. Medium boulders and cobbles displaced by flow energy. Water levels between 0.5 m and 1 m. The result of multiplying velocity (v) and height (h) ranges between $0.5 \text{ m}^2/\text{s}$ and $5 \text{ m}^2/\text{s}$ (where velocity is estimated by the paleohydraulic method).

Moderate hazard zone. Gravels and sands displaced by flow energy. Water levels below 0.5 m and/or the result of multiplying velocity (v) and height (h) does not exceed $0.5 \text{ m}^2/\text{s}$ (where velocity is estimated by the paleohydraulic method).
